Observation of microstructures of atmospheric ice using a new replica technique

Abstract

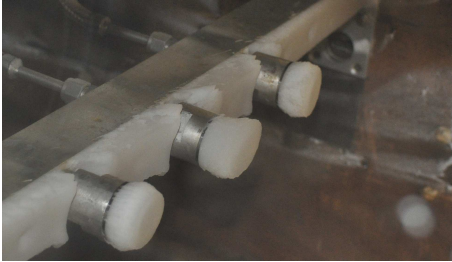
Figure 1: Samples of ice accreted on the front face of metallic cylinders ($T=-15^{\circ}\text{C}$, $V=80\text{ m.s}^{-1}$, $\text{LWC}=0.3\text{ g.m}^{-3}$, $\text{MVD}=20\text{ }\mu\text{m}$)

Samples of ice were produced in Cranfield Icing Tunnel (Hammond, 2003) as a by product of mechanical tests. Ice was accreted on the front face of cylinders made of either Titanium alloy Ti-6Al-4V or Aluminium alloy Al2024-T3 (figure 1). The substrate surfaces were

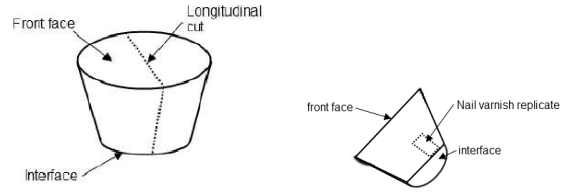
Figure 2: surface replica of the ice sample

peeled off the ice giving the replica including imprint of the peaks and groves present on the ice surface. Three different types of replica were collected representing different orientations and regions of each ice specimen. These are shown in figure 2.

The three types of replicas collected are referred as follows:

- the surface which was in contact with the substrate (called the interface)
- the surface at the other extremity (called the front surface)
- a longitudinal surface which was obtained by cutting the ice piece normal to the substrate surface

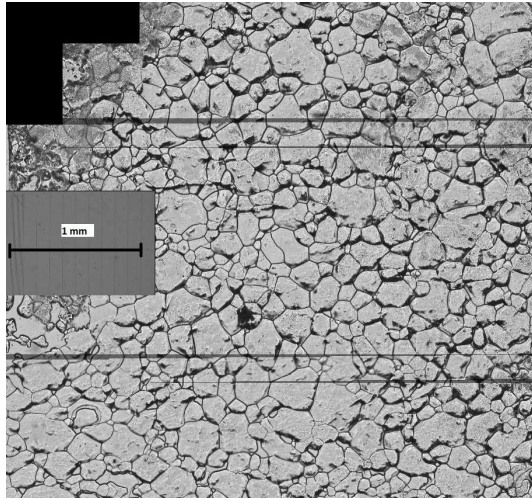
Figure 3: Microstructure of the interface of ice built on a mirror polished surface finish titanium alloy substrate ($T=-5^{\circ}\text{C}$, $\text{LWC}=0.3 \text{ g.m}^{-3}$, $V=50 \text{ m.s}^{-1}$, $\text{MVD}=20 \mu\text{m}$)

Figure 3 shows the aspect of the grain at the interface ice/substrate. The polycrystalline structure of this type of ice was clearly visible. The average size of the grains was $155 \mu\text{m}$ in the plane of the section. The straight horizontal lines and the fading of light in some part of the picture is an artefact effect due to the mosaic composition of the photos. The microstructure of the far side of

Figure 3 to 5 present the three different surfaces of interest of the same piece of ice as described above. The ice was produced at a relatively high ambient tunnel temperature (-5°C), a moderate tunnel wind speed (50 m.s^{-1}) and relatively low LWC (0.3 g.m^{-3}). The resulting ice had a transparent aspect but was not completely glaze. The deposit temperature, measured with a thermocouple placed inside the metallic cylinder (on which the ice was accreted on) close to the surface, was slightly below the melting point of ice at -1°C . The freezing fraction (fraction of the liquid water that becomes ice on impingement) was estimated around 0.5.

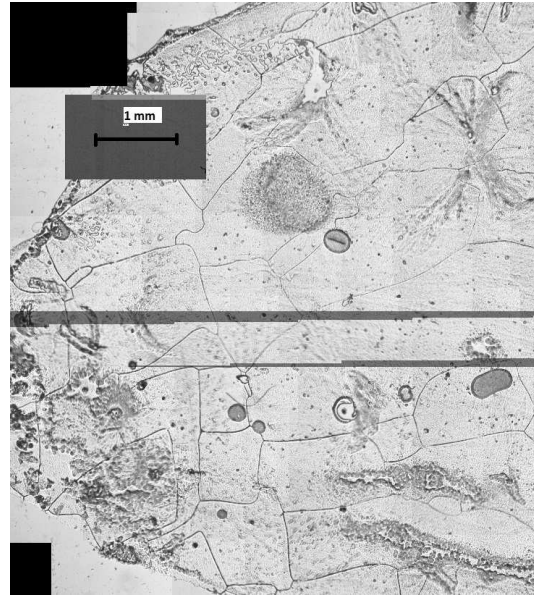
Figure 4: Microstructure of the front face of ice built on a mirror polished surface finish titanium alloy substrate ($T=-5^{\circ}\text{C}$, $\text{LWC}=0.3 \text{ g.m}^{-3}$, $V=50 \text{ m.s}^{-1}$, $\text{MVD}=20 \mu\text{m}$)

the ice block, the front side, can be observed in figure 4. Even if the scale is slightly different, it can immediately be seen that the grains are much larger than at the interface. The average size of the grains was $1094 \mu\text{m}$. A few round big bubbles can be spotted. These are water bubbles that have been trapped when the ice replica was sandwiched between the microscope slide and the cover slip for the observation under the microscope. More details of the evolution of the grain structure can be observed in figure 5. This figure represents the microstructure on a longitudinal cut through the ice piece. The part closer to the interface is on the bottom side of the picture while the front face is on the top side. The grains can be seen to have a columnar structure. They are much narrower at the interface and gradually became wider near the front face. The black spots are the results of crystallisation of the nail varnish replica and are an artefact obtained when the nail varnish is left for too long on the ice sample during the replication process.

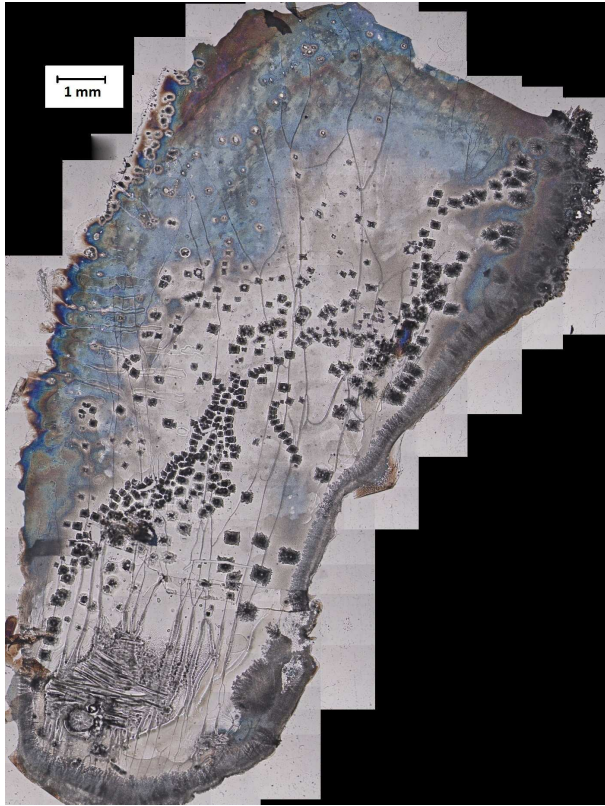
Figure 5: Microstructure of the longitudinal cut of ice built on a mirror polished surface finish titanium alloy substrate ($T=-5^{\circ}\text{C}$, $\text{LWC}=0.3\text{ g.m}^{-3}$, $V=50\text{ m.s}^{-1}$, $\text{MVD}=20\text{ }\mu\text{m}$)

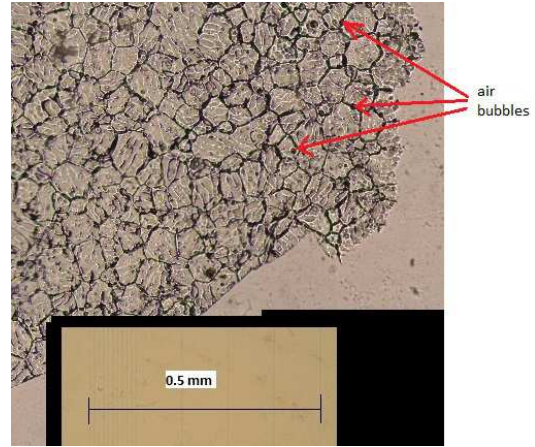
Tiny air bubbles can be seen on figure 6 as small black dots especially present along the grain boundaries. This picture represents the interface part of an ice sample grown on mirror polished aluminium alloy at a tunnel total temperature of -20°C , a speed of 50 m.s^{-1} , a LWC of 0.3 g.m^{-3} and a droplet mean volume diameter of $20\text{ }\mu\text{m}$. These icing conditions resulted in an ice sample which had a white appearance and a freezing fraction of 1. This means that each droplets coming into contact with the metallic surface would freeze completely when impinging the surface. This type of ice is commonly referred as rime ice. On this particular example, the average size of the grains was $52\text{ }\mu\text{m}$ and the size of the air bubbles was around $10\text{ }\mu\text{m}$.

Figure 6: Microstructure of the interface of ice built on a mirror polished surface finish aluminium alloy substrate ($T=-20^{\circ}\text{C}$, $\text{LWC}=0.3\text{ g.m}^{-3}$, $V=50\text{ m.s}^{-1}$, $\text{MVD}=20\text{ }\mu\text{m}$)

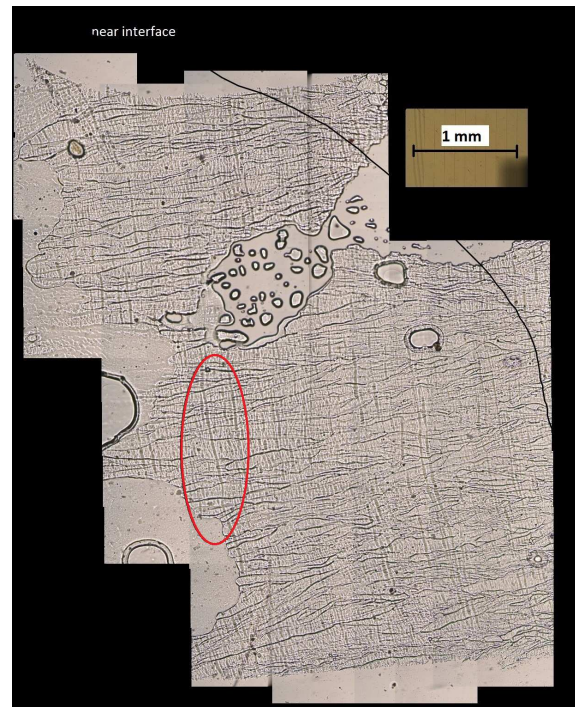
Figure 7: Microstructure of the longitudinal cut of ice built on a mirror polished surface finish titanium alloy substrate ($T=-15^{\circ}\text{C}$, $\text{LWC}=0.3\text{ g.m}^{-3}$, $V=80\text{ m.s}^{-1}$, $\text{MVD}=20\text{ }\mu\text{m}$)

as porosity and described previously by Laforte et al. (1983), can be spotted on figure 7 (an example of them has been circled in black on the figure). This picture represents the microstructure of a longitudinal cut of a sample of ice grown on mirror polished titanium alloy at a temperature of -15°C . The grains here were columnar

and relatively elongated in respect to their width (aspect ratio of around 20). A few of the black round dots described before can be spotted but more interestingly, some faint wavy vertical lines can be observed almost perpendicular to the grain boundaries. These are made of tiny bubbles and represent variations in fine porosity. They also allow us to visualise the advancement of the growth of the ice front.

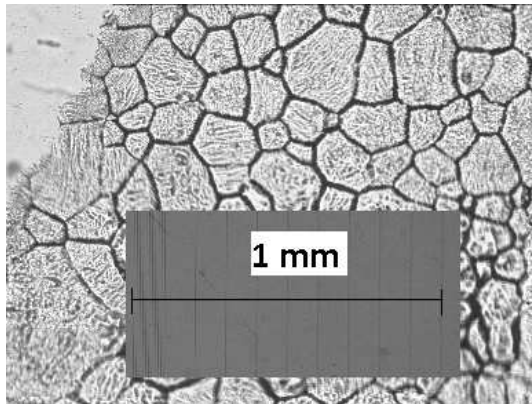
Figure 8: Microstructure of the interface of ice built on a mirror polished surface finish aluminium alloy substrate ($T=-10^{\circ}\text{C}$, $\text{LWC}=0.8\text{ g.m}^{-3}$, $V=50\text{ m.s}^{-1}$, $\text{MVD}=20\text{ }\mu\text{m}$)

On figure 8, faded greyish non continuous small lines can be spotted inside most of the grains. These are thought to be arrays of thermal etch pits and can give some indication of the orientation of the crystal c-axis.

The last feature described in this paper have been previously reported by Nasello et al. (1987) and Kriston et al. (2016). It was only observed when the size of the grains were reasonably wide (above $100\text{ }\mu\text{m}$).
